# Substation Defect Handbook

Document No. SMI 0002

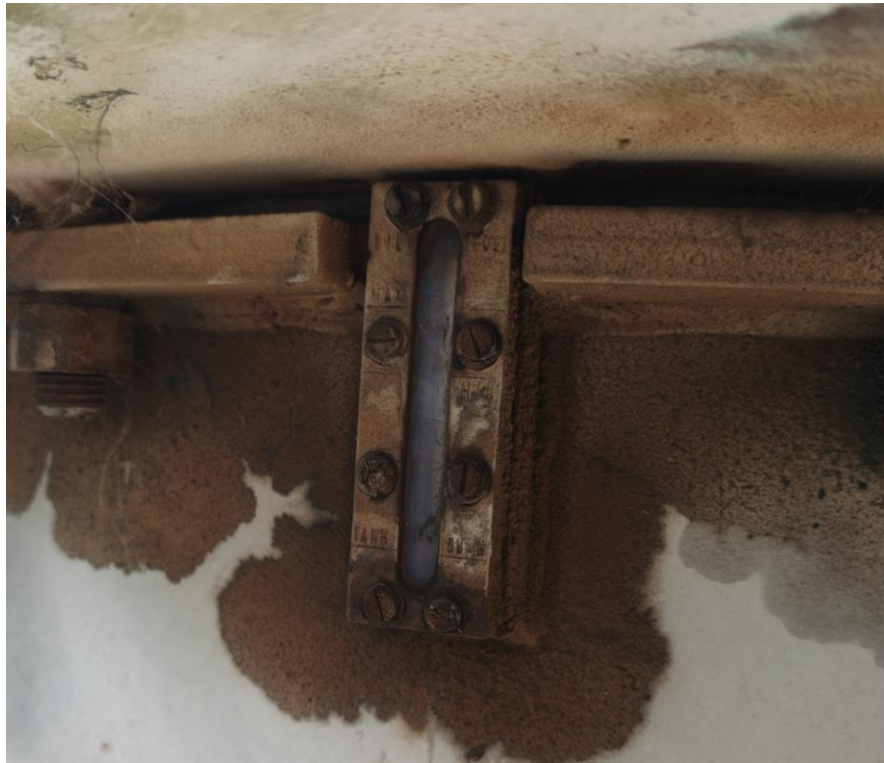
| Defect Description | Defect Photo | Task Details |
|---|---|---|
| <b>Min &amp; Bulk Oil CB</b><br>– Low Oil | | <b><u>Bushfire Defect</u></b><br><br>- No |
| <b><u>Indicators</u></b><br><br>- Oil level low on the indicator<br><br>- Alarms present on SCADA<br><br>- Visible oil on the equipment or ground<br><br>Major defects: When oil level is below or likely to be below the minimum oil level before the next inspection interval | | <b><u>Object Part</u></b><br><br>1353: Chamber |
| <b><u>Scope of Rectification Works</u></b><br><br>Top up the oil and clean up the site of any oil stains. | | |

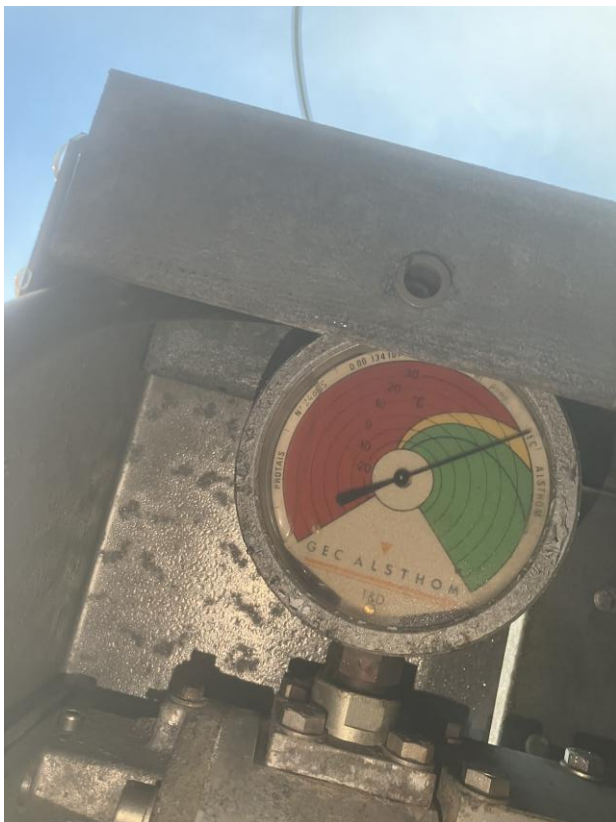
| Defect Description | Defect Photo | Task Details |
|---|---|---|
| <p><b>SF6 CB</b><br/><b>– SF6 Level Low</b></p> | | <p><b><u>Bushfire Defect</u></b></p> <ul style="list-style-type: none"><li>- No</li></ul> |
| <p><b><u>Indicators</u></b></p> <ul style="list-style-type: none"><li>- Pressure gauge reading is out of limits</li><li>- Alarms present on SCADA</li><li>- CB has entered "Low Gas Lockout"</li></ul> <p>Major defects: When CB has entered or is close to locking out from low SF6 Gas</p> | | <p><b><u>Object Part</u></b></p> <ul style="list-style-type: none"><li>- 1353: Chamber</li><li>- 1261: Gauge</li></ul> |
| <p><b><u>Scope of Rectification Works</u></b></p> <p>Top up SF6 to required levels and ensure all alarms have cleared. If CB had entered "Low Gas Lock Out", ensure alarms have cleared and the CB is operational prior to leaving site.</p> | | |

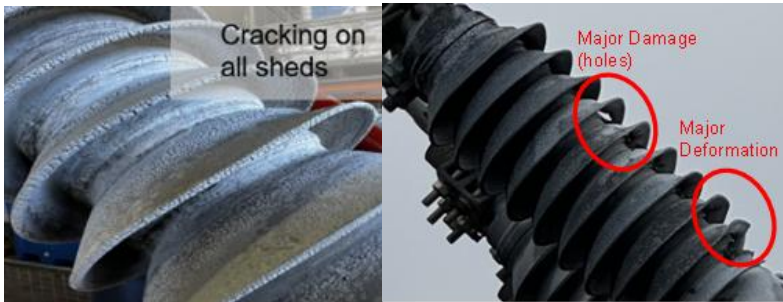
| Defect Description | Defect Photo | Task Details |
|---|---|---|
| <b>CB Bushings<br/>– Major Damage</b> | | <b><u>Bushfire Defect</u></b><br><br>- No |
| <b><u>Indicators</u></b><br><br>Poly:<br><br>- All sheds display cracks or holes<br><br>- Major treeing/ tracking<br><br>- More than half of the sheds display major deformation or warping<br><br>Porcelain/Ceramic:<br><br>- Major cracking present<br><br>- Large chunks of insulator missing<br><br>- Major treeing/tracking | | <b><u>Object Part</u></b><br><br>- 1003: Bushing |
| <b><u>Scope of Rectification Works</u></b><br><br>Inspect surrounding bushings for signs of similar damage and replace all defective bushings as required. | | |

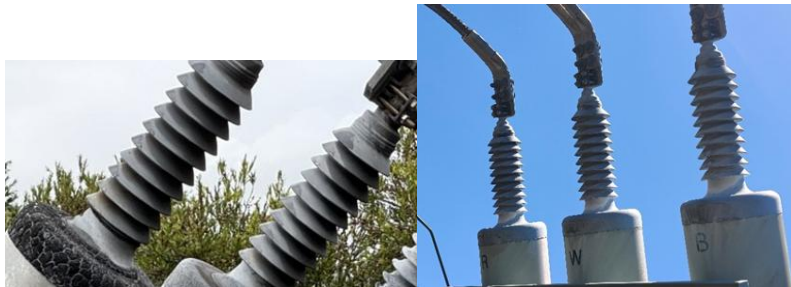
| Defect Description | Defect Photo | Task Details |
|---|---|---|
| <b>CB Bushings<br/>– Minor Damage</b> | | <b><u>Bushfire Defect</u></b><br><br>- No |
| <b><u>Indicators</u></b><br><br>Poly:<br>- Damage to 3 or more sheds.<br>- Cracking on 3 or more sheds.<br>- Insulators have lost their hydrophobic properties.<br>- Minor tracking or corona.<br><br>Porcelain/Ceramic:<br>- Minor cracking present<br>- Small chips or flakes of insulator missing<br>- Minor tracking or corona | | <b><u>Object Part</u></b><br><br>- 1003: Bushing |
| <b><u>Scope of Rectification Works</u></b><br><br>Poly: Inspect surrounding bushings for signs of similar damage. Record the defect in SAP to monitor further deterioration.<br>Ceramic: Inspect surrounding bushings for signs of similar damage. If appropriate coat exposed porcelain with Glyptal to seal the bushing. Record the defect in SAP to monitor for further deterioration | | |

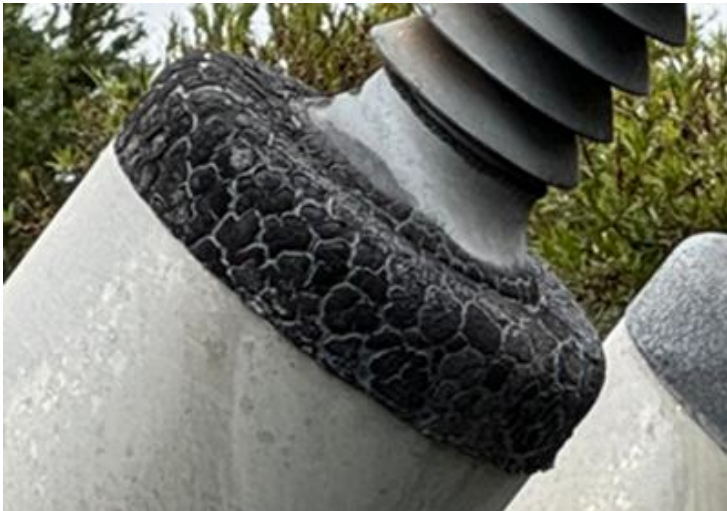
| Defect Description | Defect Photo | Task Details |
|---|---|---|
| <b>SF6 &amp; Vac CB</b><br><b>– CT Covers Cracked/ Damaged</b> | | <b><u>Bushfire Defect</u></b><br><br>- No |
| <b><u>Indicators</u></b><br><br>- CT cover boot had lost its hydrophobic properties.<br><br>- Significant cracking/damage on CT cover<br><br><br>Major defects: When the CT covers are completely deformed or showing severe signs of failure | | <b><u>Object Part</u></b><br><br>- 1003: Bushing |
| <b><u>Scope of Rectification Works</u></b><br><br>Inspect surrounding CT covers for signs of similar damage. Record the defect in SAP to monitor further deterioration. | | |

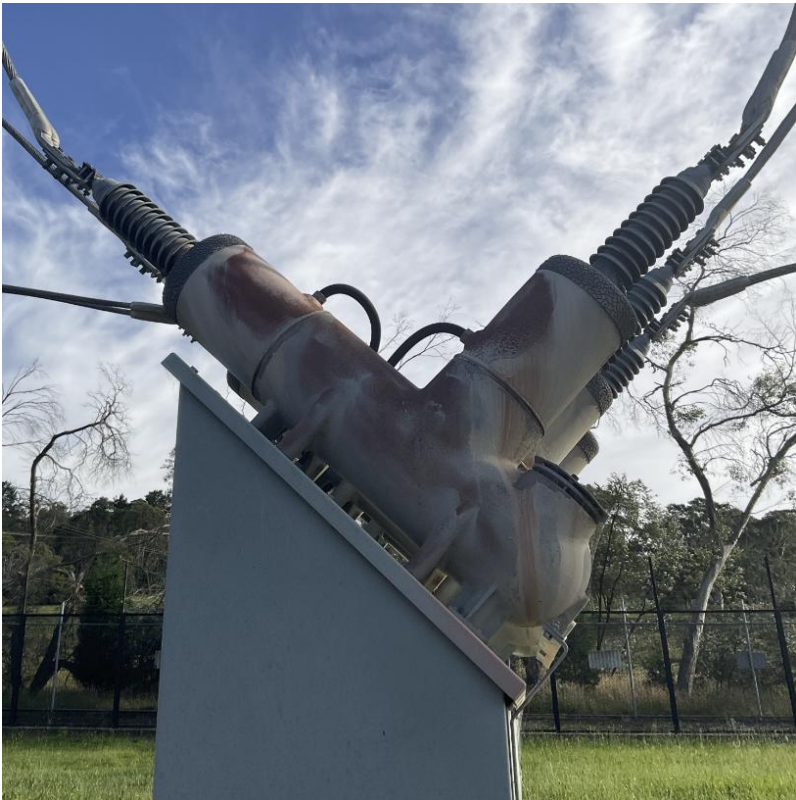
| Defect Description | Defect Photo | Task Details |
|---|---|---|
| <p><b>CB</b><br/><b>– Presence of Rust</b></p> | | <p><b><u>Bushfire Defect</u></b></p> <p>- No</p> |
| <p><b><u>Indicators</u></b></p> <p>- Rust, corrosion or discolouration present on the surface of the CB</p> <p>Major defects: When rust is more severe than surface rust and is starting to damage the CB</p> | | <p><b><u>Object Part</u></b></p> <p>- 1450: Housing</p> |
| <p><b><u>Scope of Rectification Works</u></b></p> <p>Minor: Where possible, remove rust and seal the surface of the affected area to prevent further corrosion. Monitor for any further deterioration</p> <p>Major: Replace the rusted component</p> | | |

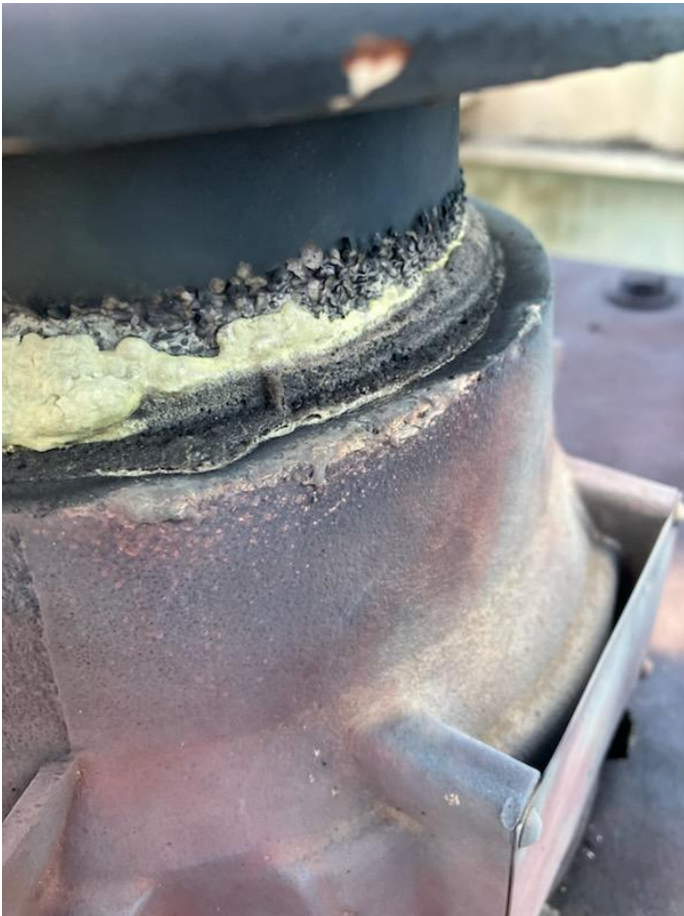
| Defect Description | Defect Photo | Task Details |
|---|---|---|
| <b>CB HV Termination</b><br>– Rusted/ Corroded/ Overheating | | <b><u>Bushfire Defect</u></b><br><br>- No |
| <b><u>Indicators</u></b><br><br>- Visible signs of burning<br>- Hot joints<br>- Major corrosion/ rust<br>- High contact resistance | | <b><u>Object Part</u></b><br><br>- 1355: Terminal<br>- 1354: Palm<br>- 1352: Contacts |
| <b><u>Scope of Rectification Works</u></b><br>Conduct a thermal imaging scan of termination and surrounding equipment if required. Identify the cause of the fault and clean or re-terminate as required. Test connections prior to re-energisation. | | |

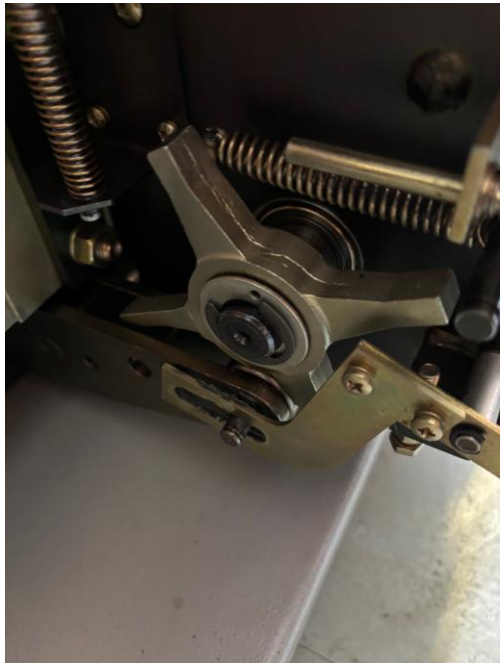
| Defect Description | Defect Photo | Task Details |
|---|---|---|
| <b>CB Mech</b><br>– Mech or Rollers Faulty | | <b><u>Bushfire Defect</u></b><br><br>- No |
| <b><u>Indicators</u></b><br><br>- CB is slow to operate<br>- CB won't open/close<br>- Roller bearings are stiff to rotate by hand | | <b><u>Object Part</u></b><br><br>- 1277: Mechanism |
| <b><u>Scope of Rectification Works</u></b><br><br>- Remove, clean and re-lubricate roller bearings and mechanism using approved lubricant<br>- Replace roller bearings or mechanism as required and ensure CB is operational prior to leaving site. | | |

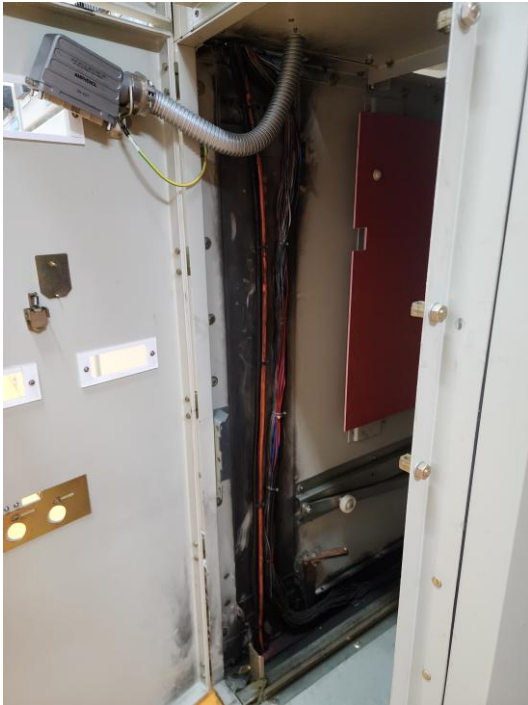
| Defect Description | Defect Photo | Task Details |
|---|---|---|
| <b>CB Secondaries</b><br>– Cabling/Equipment Faulty | | <b><u>Bushfire Defect</u></b><br><br>- No |
| <b><u>Indicators</u></b><br><br>- Secondary wiring looks/smells burnt<br><br>- Secondary systems not working as expected<br><br>- CB won't operate/communicate with SCADA or remote panels<br><br>- System alarms relating to CB that don't match up | | <b><u>Object Part</u></b><br><br>- N/A: Secondary Wiring |
| <b><u>Scope of Rectification Works</u></b><br>- Repair/replace any secondary wiring that is defective<br>- Repair/replace any defective secondary components as required (Links, Terminals, Fuses, etc.) and ensure CB is operational prior to leaving site. | | |

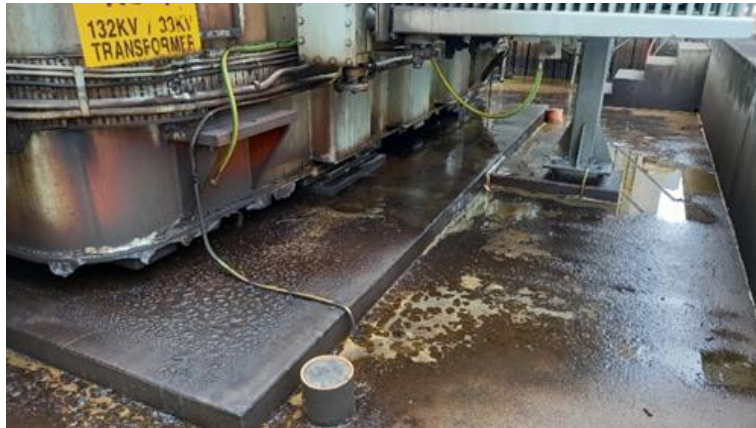
| Defect Description | Defect Photo | Task Details |
|---|---|---|
| <b>TRF</b><br><b>– Major Oil Leak</b> | | <b><u>Bushfire Defect</u></b><br><br>- No |
| <b><u>Indicators</u></b><br><br>- Frequently having to top up oil<br><br>- Oil level indicator low<br><br>- Major oil leaking from joints, gaskets, bolts, etc.<br><br>- Pooling of oil on equipment or in bund<br><br>- Frequent OWS cleaning required | | <b><u>Object Part</u></b><br><br>- 1002: Tank<br>- 1078: Gasket<br>- 1085: Piping<br>- N/A: Conservator |
| <b><u>Scope of Rectification Works</u></b><br><br>Identify the location and the cause of the leak and rectify as required. Ensure oil level is topped up to the necessary level. For any oil spills follow company standard <b>EMS 0008 - Environmental Incident Response and Management</b> | | |

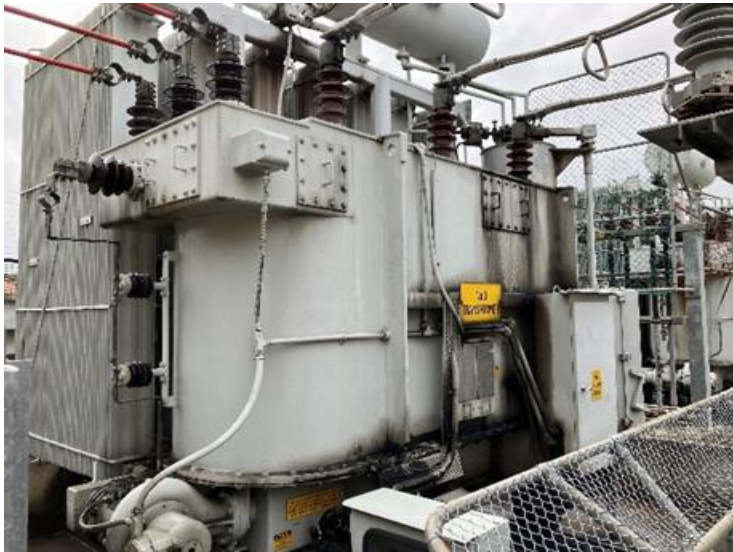
| Defect Description | Defect Photo | Task Details |
|---|---|---|
| <p><b>TRF</b><br/><b>– Minor Oil Leak</b></p> | | <p><b><u>Bushfire Defect</u></b></p> <p>- No</p> |
| <p><b><u>Indicators</u></b></p> <p>- Oil level indicator low</p> <p>- Minor oil leaking from joints, gaskets, bolts, etc.</p> <p>- Pooling of oil on equipment or in bund</p> <p>- Semi regular OWS cleaning required</p> | | <p><b><u>Object Part</u></b></p> <p>- 1002: Tank</p> <p>- 1078: Gasket</p> <p>- 1085: Piping</p> <p>- N/A: Conservator</p> |
| <p><b><u>Scope of Rectification Works</u></b></p> <p>For mild leaks, record the defect in SAP to monitor if not existing already</p> <p>For any oil spills follow company standard <b>EMS 0008 - Environmental Incident Response and Management</b></p> | | |

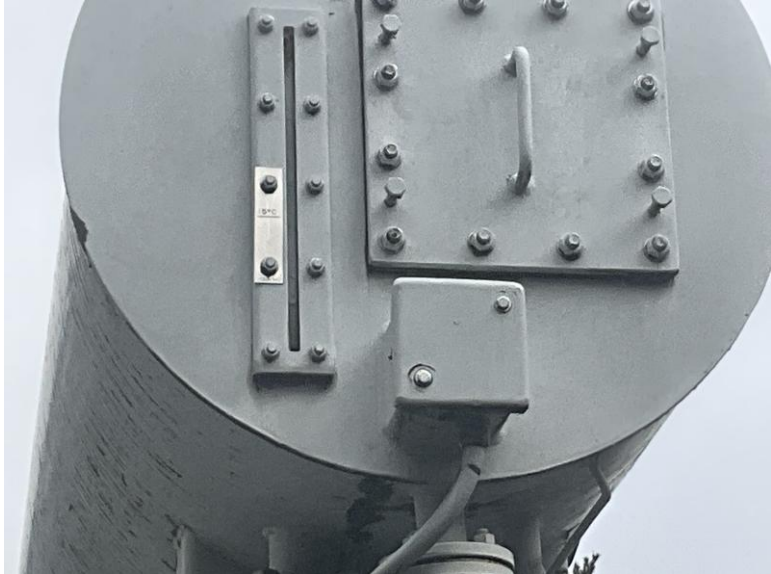
| Defect Description | Defect Photo | Task Details |
|---|---|---|
| <p><b>TRF</b><br/><b>– Oil Low</b></p> | | <p><b><u>Bushfire Defect</u></b></p> <p>- No</p> |
| <p><b><u>Indicators</u></b></p> <p>- Low oil in Main Tank conservator site glass</p> <p>- Low oil alarm on SCADA</p> <p>Major defects: When oil level is below or likely to be below the minimum oil level before the next inspection interval</p> | | <p><b><u>Object Part</u></b></p> <p>- 1002: Tank</p> <p>- N/A: Conservator</p> |
| <p><b><u>Scope of Rectification Works</u></b></p> <p>Top up the oil in the Transformer Main Tank to the required level</p> | | |

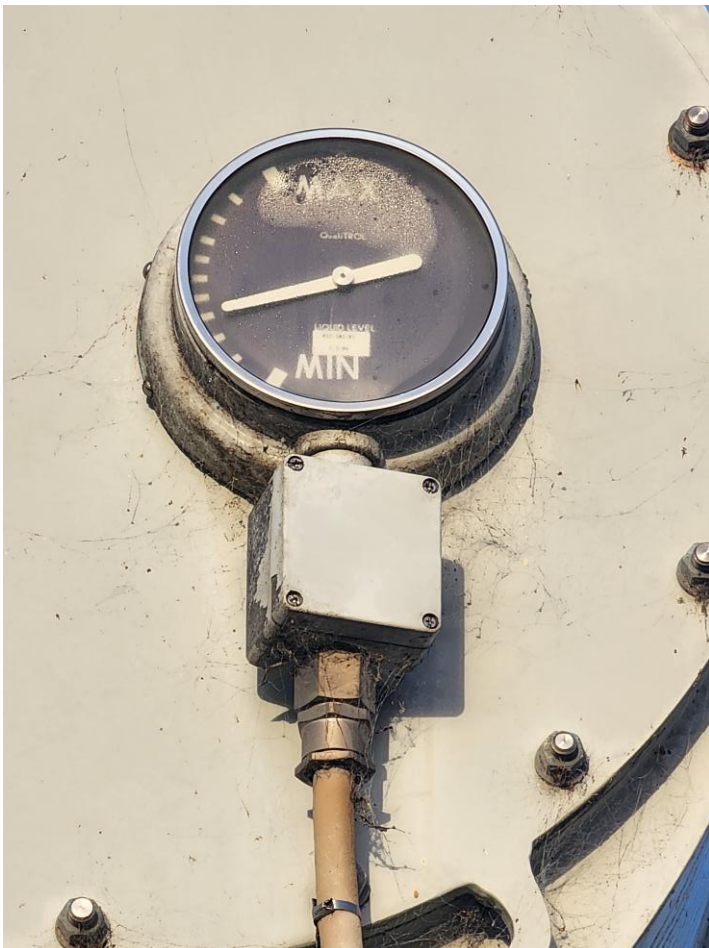
| Defect Description | Defect Photo | Task Details |
|---|---|---|
| <p><b>TRF</b></p> <p><b>– Oil Level Gauge Defective</b></p> | | <p><b><u>Bushfire Defect</u></b></p> <p>- No</p> |
| <p><b><u>Indicators</u></b></p> <p>- Sight glass dirty and can't be read</p> <p>- Sight glass cracked and leaking oil</p> <p>- Gauge full of water and sending false “Low Oil” alarms to SCADA</p> <p>Major defects: When the oil gauge is not operating or a reading is unable to be obtained</p> | | <p><b><u>Object Part</u></b></p> <p>- 1261: Gauge</p> |
| <p><b><u>Scope of Rectification Works</u></b></p> <p>- Clean or replace the sight glass as required and ensure oil level can be accurately observed from ground level</p> <p>- Dry out and re-seal, or replace oil level gauge as required and ensure alarms to SCADA are working as intended</p> | | |

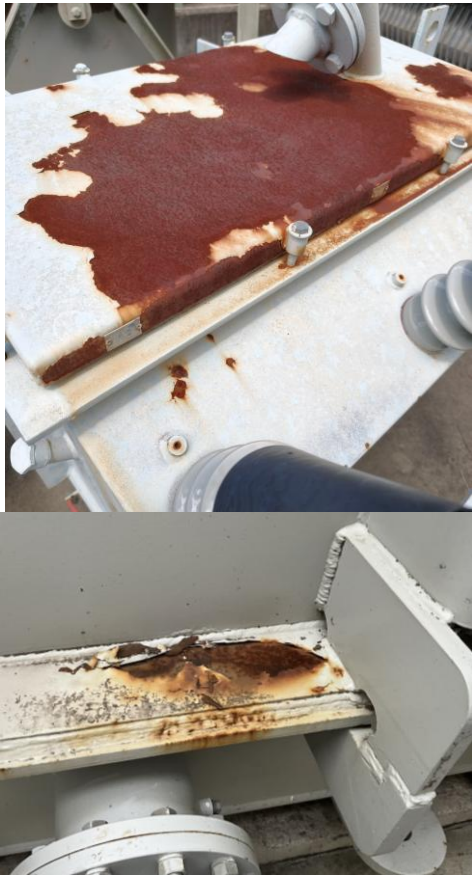
| Defect Description | Defect Photo | Task Details |
|---|---|---|
| <p><b>TRF Tank</b><br/><b>– Rusted / Damaged</b></p> | | <p><b><u>Bushfire Defect</u></b></p> <p>- No</p> |
| <p><b><u>Indicators</u></b></p> <p>- Signs of damage like cracks or rust causing the transformer to leak</p> <p>- Other major TRF tank damage</p> <p>Major defects: When rust is more severe than surface rust and is starting to damage the TRF</p> | | <p><b><u>Object Part</u></b></p> <p>- 1002: Tank</p> |

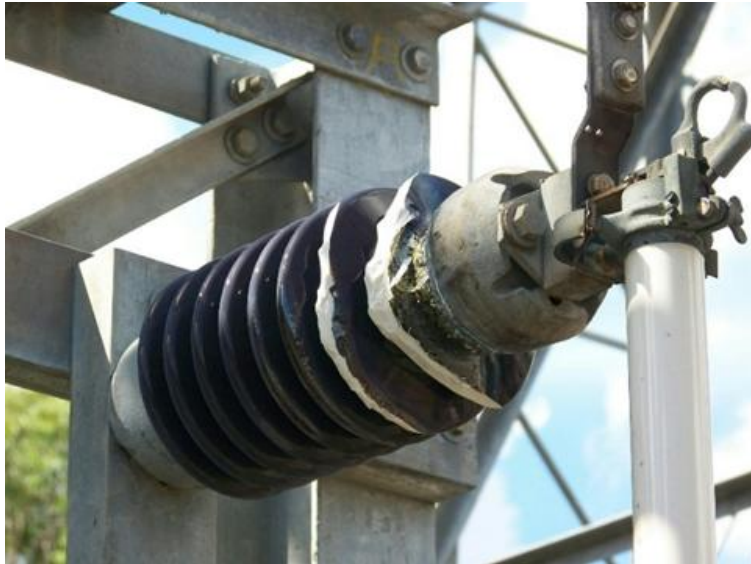
| Defect Description | Defect Photo | Task Details |
|---|---|---|
| <b>TRF Bushings<br/>– Major Damage</b> | | <b><u>Bushfire Defect</u></b><br><br>- No |
| <b><u>Indicators</u></b><br><br>- Major cracking present<br>- Large chunks of insulator missing<br>- Major treeing/tracking | | <b><u>Object Part</u></b><br><br>- 1003: Bushing |
| <b><u>Scope of Rectification Works</u></b><br>Inspect surrounding bushings for signs of similar damage and replace all defective bushings as required. | | |

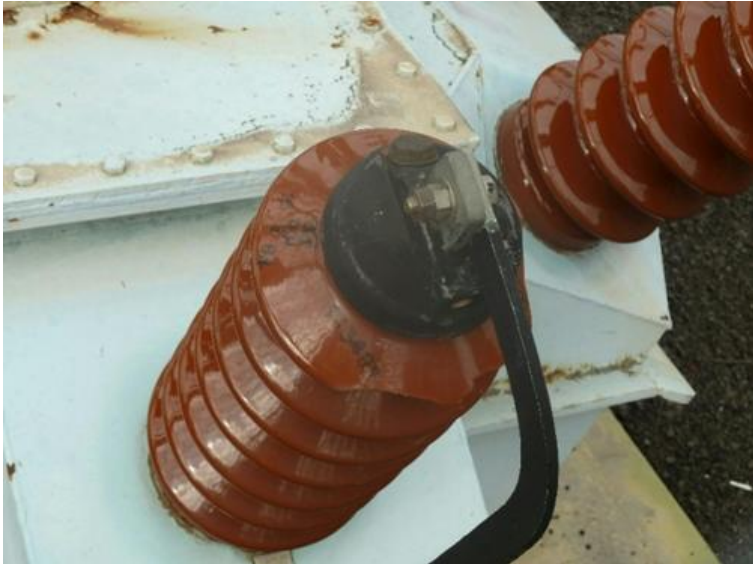
| Defect Description | Defect Photo | Task Details |
|---|---|---|
| <b>TRF Bushings<br/>– Minor Damage</b> | | <b><u>Bushfire Defect</u></b><br><br>- No |
| <b><u>Indicators</u></b><br><br>- Small chips or flakes of insulator missing<br><br>- Minor cracking present<br><br>- Some signs of tracking or corona | | <b><u>Object Part</u></b><br><br>- 1003: Bushing |
| <b><u>Scope of Rectification Works</u></b><br><br>Inspect surrounding bushings for signs of similar damage. If appropriate coat exposed porcelain with Glyptal to seal the bushing. Record the defect in SAP to monitor for further deterioration | | |

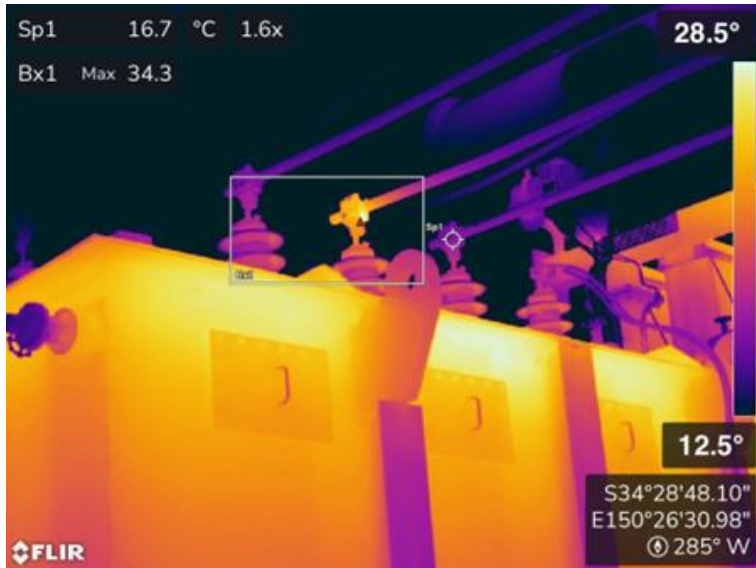
| Defect Description | Defect Photo | Task Details |
|---|---|---|
| <b>TRF HV Termination</b><br>– Rusted/ Corroded/ Overheating | | <b><u>Bushfire Defect</u></b><br><br>- No |
| <b><u>Indicators</u></b><br><br>- Visible signs of burning<br><br>- Hot joints<br><br>- Major corrosion/ rust<br><br>- High contact resistance | | <b><u>Object Part</u></b><br><br>- 1003: Bushing<br>- 1112: Conductor |
| <b><u>Scope of Rectification Works</u></b><br><br>Conduct a thermal imaging scan of termination and surrounding equipment if required. Identify the cause of the fault and clean or re-terminate as required. Test connections prior to re-energisation. | | |

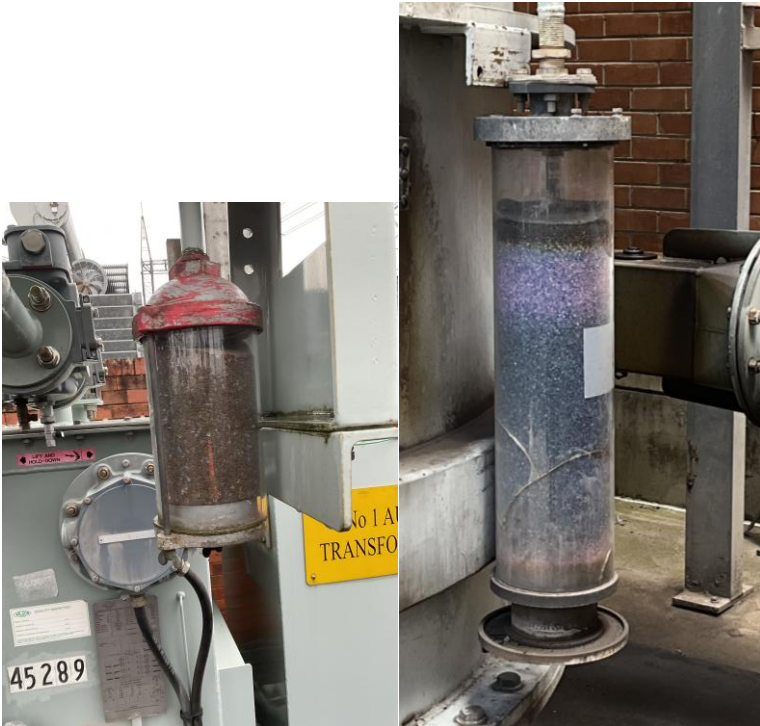
| Defect Description | Defect Photo | Task Details |
|---|---|---|
| <p><b>TRF</b></p> <p><b>– Silica Gel Deteriorated</b></p> | | <p><b><u>Bushfire Defect</u></b></p> <p>- No</p> |
| <p><b><u>Indicators</u></b></p> <p>- Silica Gel has faded to a white/pink colour</p> <p>- Silica Gel holder has cracks/signs of failure</p> <p>Major defects: When the silica gel holder has major cracks or damage or the silica gel has completely deteriorated</p> | | <p><b><u>Object Part</u></b></p> <p>- N/A: Silica Gel Breather</p> |
| <p><b><u>Scope of Rectification Works</u></b></p> <p>- Top up Silica Gel as required</p> <p>- Replace Silica Gel holder if required</p> | | |

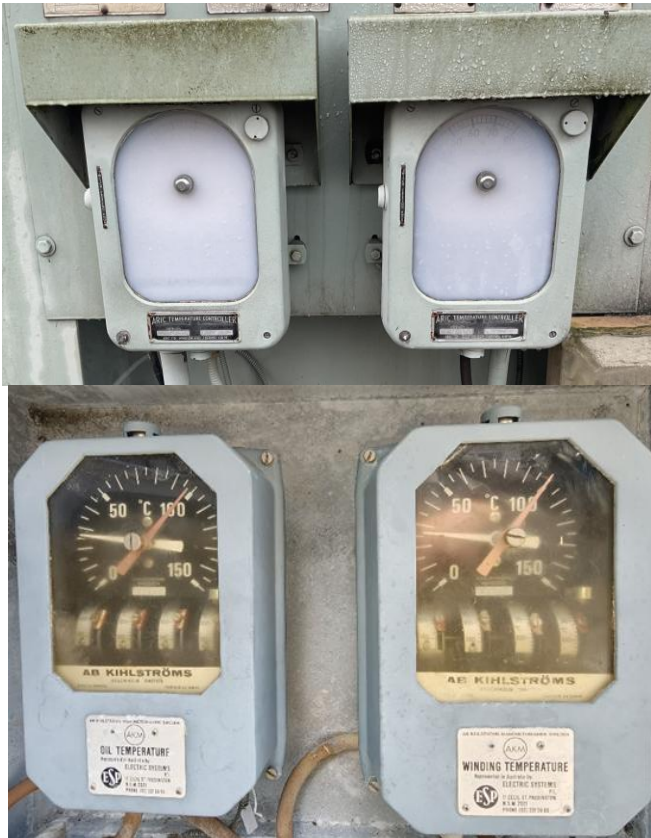
| Defect Description | Defect Photo | Task Details |
|---|---|---|
| <b>TRF Secondaries<br/>– Temperature Indicator Faulty</b> | | <b><u>Bushfire Defect</u></b><br><br>- No |
| <b><u>Indicators</u></b><br><br>- OTI or WTI indicator broken or reading illegible<br><br>- Sending false OTI and WTI readings to SCADA | | <b><u>Object Part</u></b><br><br>- 1261: Gauge |
| <b><u>Scope of Rectification Works</u></b><br>Repair or replace the OTI or WTI gauge as required. Ensure OTI and WTI gauges are commissioned and read accurately on SCADA | | |

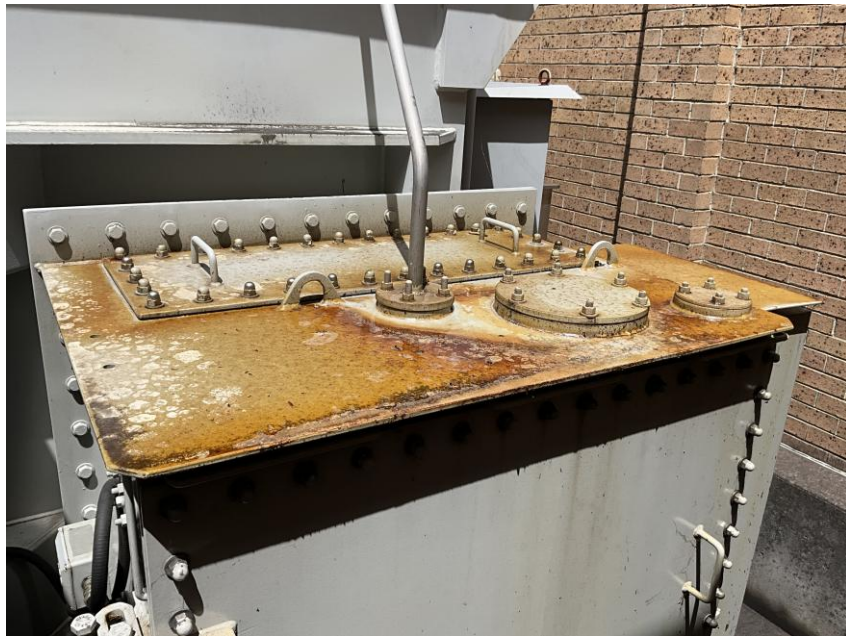
| Defect Description | Defect Photo | Task Details | |
|---|---|---|--|
| <p><b>Tap Changer<br/>– Oil Leak</b></p> | | <p><b><u>Bushfire Defect</u></b></p> <p>- No</p> | |
| <p><b><u>Indicators</u></b></p> <p>- Frequently having to top up oil</p> <p>- Oil level indicator low</p> <p>- Oil leaking from joints, gaskets, bolts, etc.</p> <p>- Pooling of oil on equipment or in bund</p> <p>Major defects: When top ups are required less than 6-month intervals</p> | | <p><b><u>Object Part</u></b></p> <p>- 1002: Tank</p> <p>- 1078: Gasket</p> <p>- 1085: Piping</p> <p>- N/A: Conservator</p> | |
| <p><b><u>Scope of Rectification Works</u></b></p> <p>For major leaks, repair of leak should be attempted (replacing gaskets, bushing replacements, epoxy sealing)</p> <p>For minor leaks, record the defect in SAP to monitor if not existing already.</p> <p>For any oil spills follow company standard <b>EMS 0008 - Environmental Incident Response and Management</b></p> | | | |

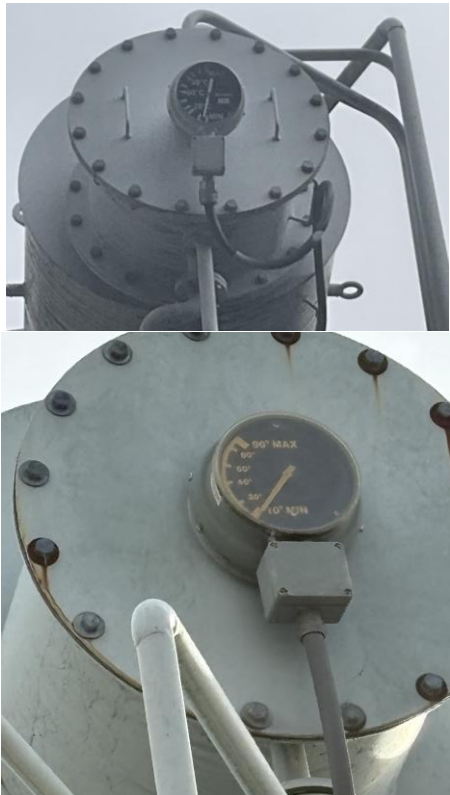
| Defect Description | Defect Photo | Task Details |
|---|---|---|
| <p><b>Tap Changer<br/>– Oil Low</b></p> | | <p><b><u>Bushfire Defect</u></b></p> <p>- No</p> |
| <p><b><u>Indicators</u></b></p> <p>- Low oil in Tap Changer conservator sight glass</p> <p>- Low oil alarm on SCADA</p> <p>Major defects: When oil level is below or likely to be below the minimum oil level before the next inspection interval</p> | | <p><b><u>Object Part</u></b></p> <p>- 1002: Tank</p> <p>- N/A: Conservator</p> |

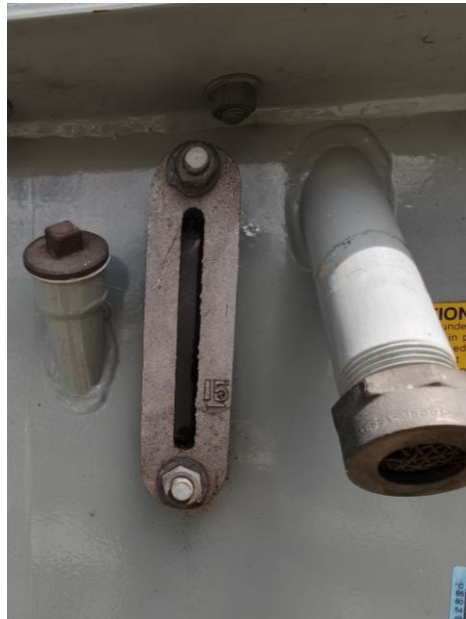
| Defect Description | Defect Photo | Task Details | |
|---|---|---|--|
| <p><b>Instrument TRF</b><br/><b>– Oil Leak</b></p> | | <p><b><u>Bushfire Defect</u></b></p> <p>- No</p> | |
| <p><b><u>Indicators</u></b></p> <p>- Frequently having to top up oil</p> <p>- Oil level indicator low</p> <p>- Oil leaking from joints, gaskets, bolts, etc.</p> <p>- Pooling of oil on equipment or on the ground</p> <p>Major defects: When top ups are required less than 6-month intervals</p> | | <p><b><u>Object Part</u></b></p> <p>- 1002: Tank</p> <p>- N/A: Conservator</p> | |

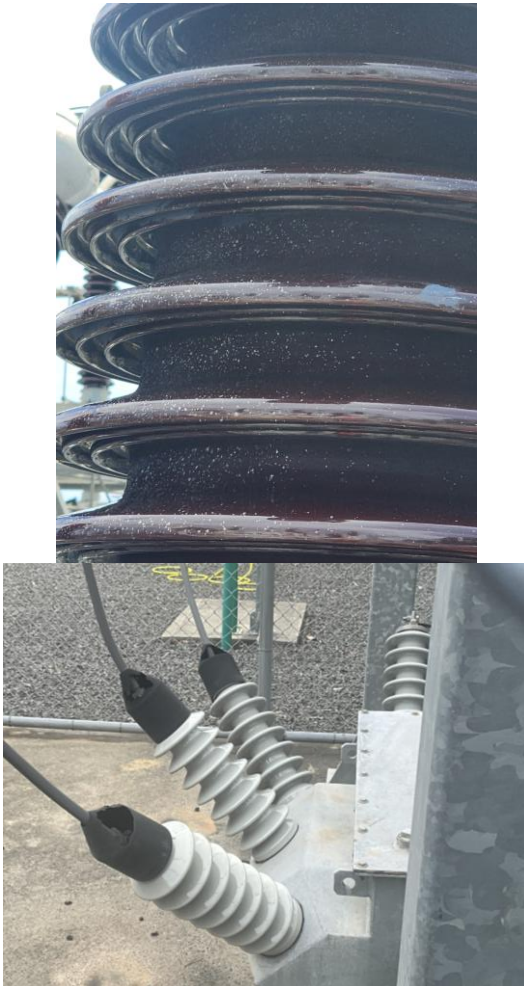
| Defect Description | Defect Photo | Task Details |
|---|---|---|
| <b>Instrument TRF Bushings<br/>– Minor Damage</b> | | <b><u>Bushfire Defect</u></b><br><br>- No |
| <b><u>Indicators</u></b><br><br>- Small chips or flakes of insulator missing<br><br>- Minor cracking present<br><br>- Some signs of tracking or corona | | <b><u>Object Part</u></b><br><br>- 1003: Bushing |
| <b><u>Scope of Rectification Works</u></b><br><br>Inspect surrounding bushings for signs of similar damage. If appropriate coat exposed porcelain with Glyptal to seal the bushing. Record the defect in SAP to monitor for further deterioration | | |

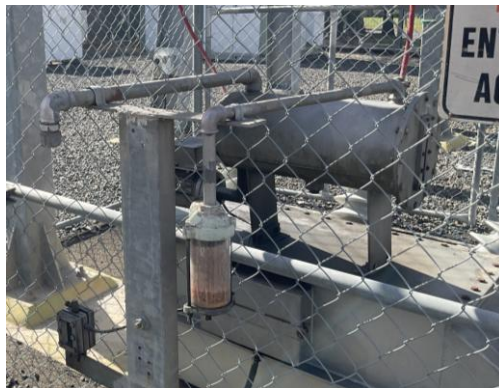
| Defect Description | Defect Photo | Task Details |
|---|---|---|
| <b>Instrument TRF</b><br><b>– Silica Gel Deteriorated</b> | | <b><u>Bushfire Defect</u></b><br><br>- No |
| <b><u>Indicators</u></b><br><br>- Silica Gel has faded to a white/pink colour<br><br>- Silica Gel holder has cracks/signs of failure<br><br>Major defects: When the silica gel holder has major cracks or damage or the silica gel has completely deteriorated | | <b><u>Object Part</u></b><br><br>- N/A: Silica Gel Breather |
| <b><u>Scope of Rectification Works</u></b><br><br>- Top up Silica Gel as required<br>- Replace Silica Gel holder if required | | |

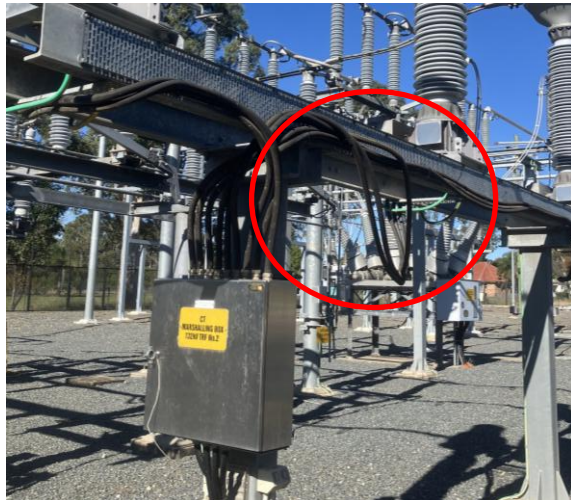
| Defect Description | Defect Photo | Task Details |
|---|---|---|
| <b>Instrument TRF Secondaries<br/>– Cabling/Equipment Faulty</b> | | <b><u>Bushfire Defect</u></b><br><br>- No |
| <b><u>Indicators</u></b><br><br>- Secondary wiring looks/smells burnt<br><br>- Secondary systems not working as expected<br><br>- Instrument TRF won't operate/communicate with SCADA or remote panels<br><br>- System alarms relating to Instrument TRF that don't match up<br><br>Major defects: When the Tap Changer is unable to be operated as required | | <b><u>Object Part</u></b><br><br>- N/A: Secondary Wiring |

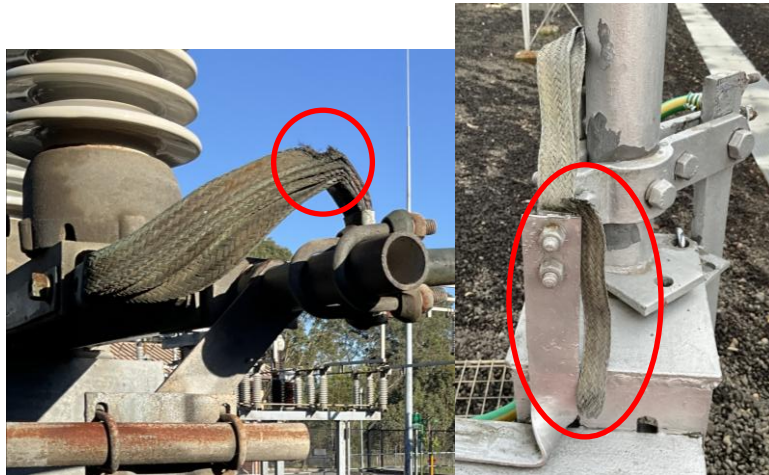
| Defect Description | Defect Photo | Task Details |
|---|---|---|
| <b>Isolators &amp; E/S</b><br>– Damaged or Defective Earthing | | <b><u>Bushfire Defect</u></b><br><br>- No |
| <b><u>Indicators</u></b><br><br>- Earthing braids are frayed or damaged<br><br>- Earthing is not as per technical specifications<br><br>- Earthing is showing signs of deterioration<br><br>Major defects: When the earthing poses a hazard to the safety of staff or the network | | <b><u>Object Part</u></b><br><br>- N/A: Equipment Earthing |

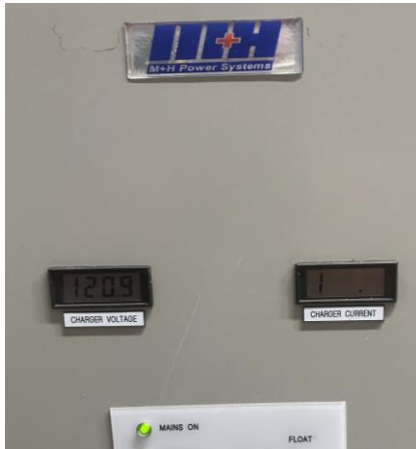
| Defect Description | Defect Photo | Task Details |
|---|---|---|
| <b>Battery Charger<br/>– Defective / Faulty</b> | | <b><u>Bushfire Defect</u></b><br><br>- No |
| <b><u>Indicators</u></b><br><br>- Battery Charger does not charge battery bank to required voltage<br><br>- Float or Boost charge does not operate as expected<br><br>- Charger voltage and current readings are not displaying<br><br>- Charger output does not match measured readings<br><br>Major defects: When the battery charger is not charging the batteries as required | | <b><u>Object Part</u></b><br><br>- 1413: Charger Card<br>- N/A: LV Fuses/CB/RCD |

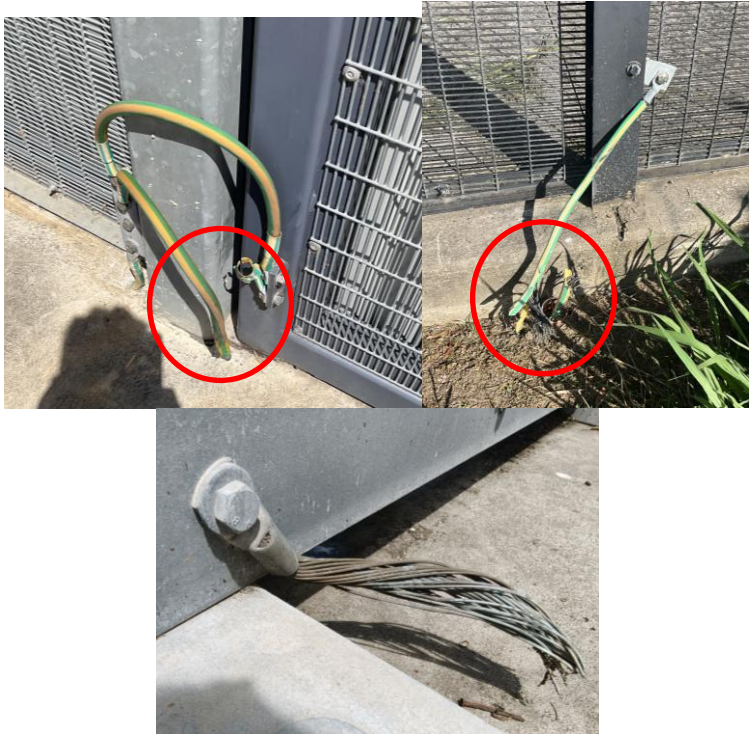
| Defect Description | Defect Photo | Task Details |
|---|---|---|
| <b>Earthing Conductor – Missing / Damaged</b> | | <b><u>Bushfire Defect</u></b><br><br>- No |
| <b><u>Indicators</u></b><br><br>- Earthing conductor has missing or broken strands<br><br>- Earthing connections are loose or deteriorating<br><br>- Earthing does not comply with Earthing Design Report or EDI 516<br><br>Major defects: When the earthing poses a hazard to the safety of staff or the network | | <b><u>Object Part</u></b><br><br>- 1405: Cable<br>- N/A: Equipment Earthing |
| <b><u>Scope of Rectification Works</u></b><br>Repair or replace the damaged earthing conductor or terminations and ensure that earthing complies to <b>EDI 516 – Major substation earthing design, construct and commissioning</b> | | |

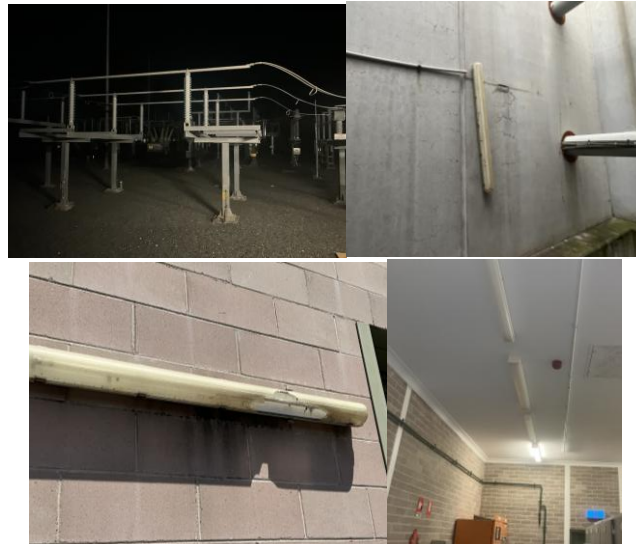
| Defect Description | Defect Photo | Task Details |
|---|---|---|
| <p><b>Lighting</b><br/>– Damaged or Poor Condition</p> | | <p><b><u>Bushfire Defect</u></b></p> <p>- No</p> |
| <p><b><u>Indicators</u></b></p> <p>- Lighting is inoperable</p> <p>- Lighting is inadequate for required area</p> <p>- Light fittings are cracked/damaged</p> <p>- Light fittings are not properly secured</p> <p>Major defects: When the lighting is inoperable or poses a hazard to the safety of staff or the network</p> | | <p><b><u>Object Part</u></b></p> <p>- 1405: Cable</p> <p>- N/A: Light</p> <p>- N/A: LV Fuses/CB/RCD</p> |
| <p><b><u>Scope of Rectification Works</u></b></p> <p>Repair / Replace lighting as required to ensure adequate site lighting</p> | | |

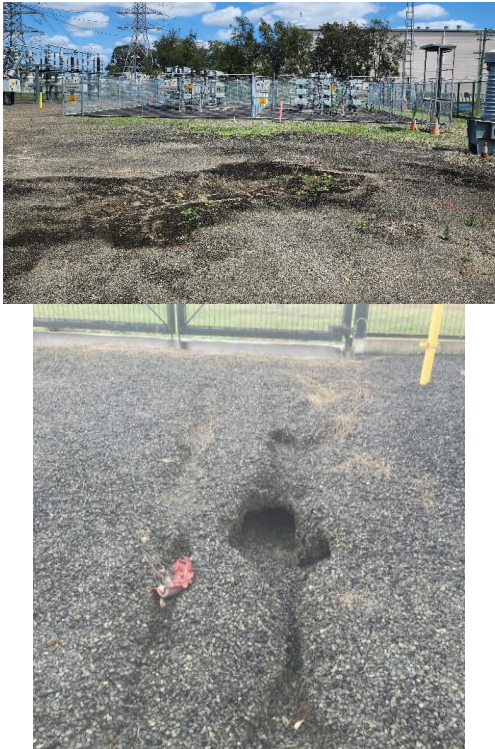
| Defect Description | Defect Photo | Task Details |
|---|---|---|
| <b>Switch Yard Blue Metal – Missing or Poor Condition</b> | | <b><u>Bushfire Defect</u></b><br><br>- No |
| <b><u>Indicators</u></b><br><br>- Blue Metal coverage is not adequate<br>- Large areas of dirt visible in yard<br>- Sink holes are forming<br><br>Major defects: When the damage poses a hazard to the safety of staff or the network | | <b><u>Object Part</u></b><br><br>- 1553: Concrete Stones |
| <b><u>Scope of Rectification Works</u></b><br><br>- For minor issues, replenish the blue metal as required<br>- For major issues, submit notification and raise a DRA. | | |

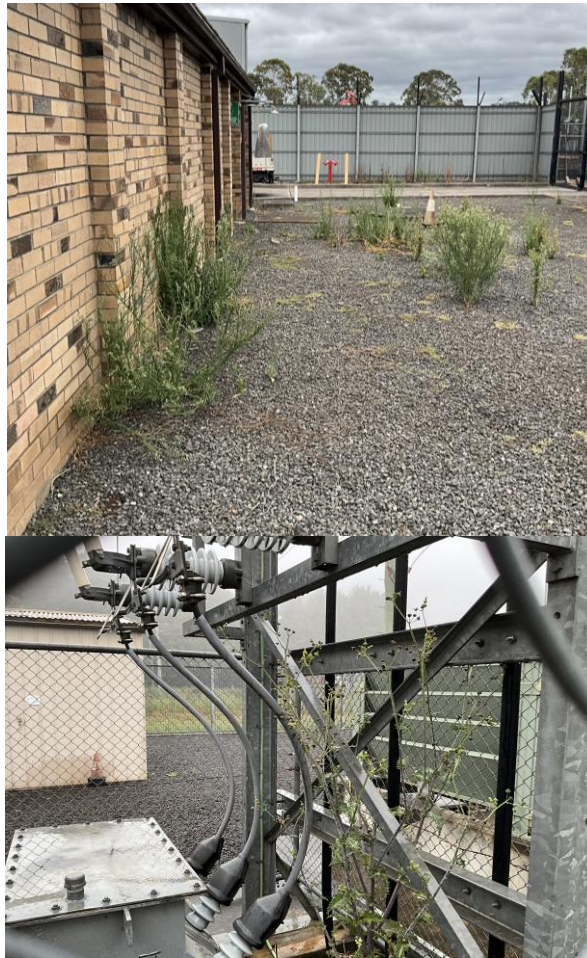
| Defect Description | Defect Photo | Task Details | |
|---|---|---|--|
| <p><b>Switch Yard</b><br/><b>– Overgrown Weeds</b></p> | | <p><b><u>Bushfire Defect</u></b></p> <p>- No</p> | |
| <p><b><u>Indicators</u></b></p> <p>- Vegetation growing in switch yard</p> <p>- Vegetation encroaching on clearances</p> <p>Major defects: When weeds are starting to encroach on equipment or is becoming a trip hazard to staff</p> | | <p><b><u>Object Part</u></b></p> <p>- 1553: Concrete Stones</p> | |
| <p><b><u>Scope of Rectification Works</u></b></p> <p>- Spray the vegetation as required and remove any excess weeds from the switch yard</p> <p>- For any compromised clearances – Contact control room and organise an outage to remove vegetation</p> | | | |

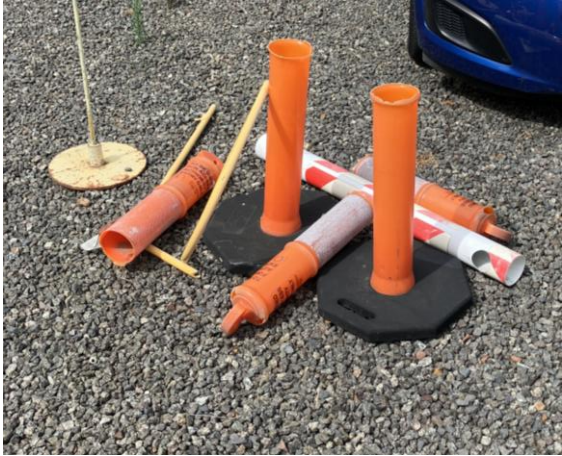
| Defect Description | Defect Photo | Task Details |
|---|---|---|
| <b>Switch Yard</b><br><b>– AA Stands / Bollards Damaged</b> | | <b><u>Bushfire Defect</u></b><br>- No |
| <b><u>Indicators</u></b><br><ul style="list-style-type: none"> <li>- Stands and Bollards are damaged</li> <li>- Stands are faded and are no longer yellow</li> <li>- Bollards are UV damaged</li> </ul> | | <b><u>Object Part</u></b><br>- N/A: AA Stands/Bollards |
| <b><u>Scope of Rectification Works</u></b><br>Repair / Replace all defective AA stands and Bollards as required. Ensure that there is an adequate amount on site and that they are stored out of the weather. | | <b><u>Cause Code</u></b><br><ul style="list-style-type: none"> <li>- 1006: Cracked</li> <li>- 1059: Mechanical Failure</li> <li>- 1359: Age</li> <li>- 1164: Unknown</li> </ul> |

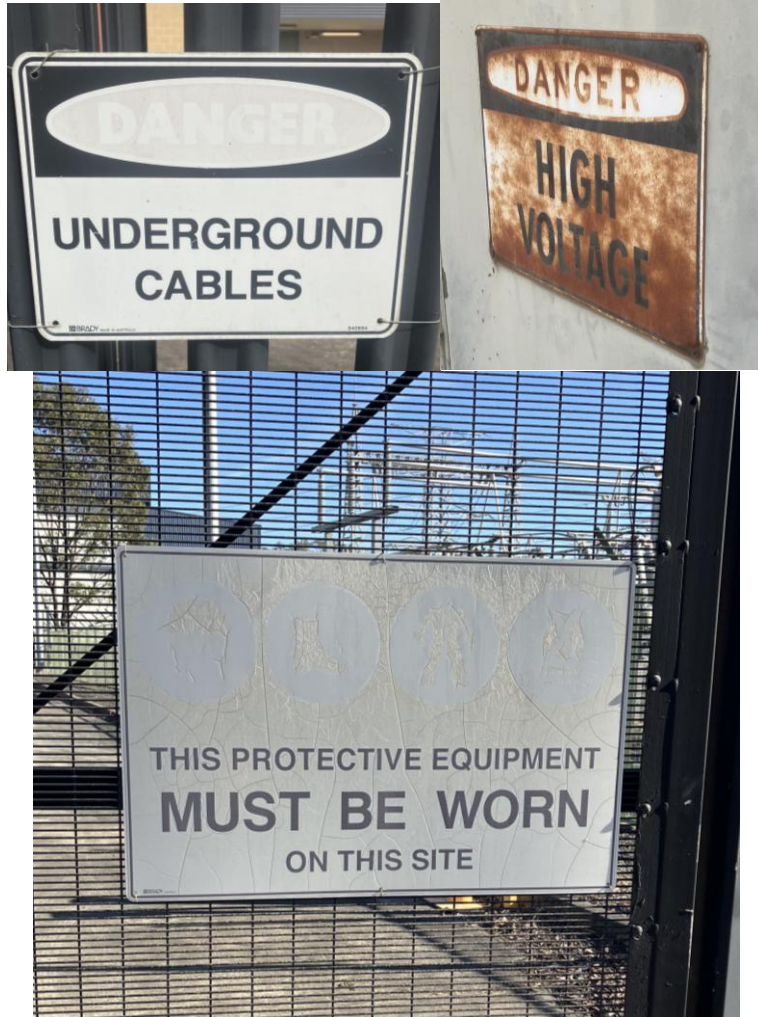
| Defect Description | Defect Photo | Task Details |
|---|---|---|
| <b>Substation Signage</b><br>– Missing / Poor Condition | | <b><u>Bushfire Defect</u></b><br><br>- No |
| <b><u>Indicators</u></b><br><br>- Signs are illegible<br>- Signs are missing<br>- Signs are not secured appropriately | | <b><u>Object Part</u></b><br><br>- N/A: Sign |
| <b><u>Scope of Rectification Works</u></b><br>Repair / Replace the defective signage as required | | |

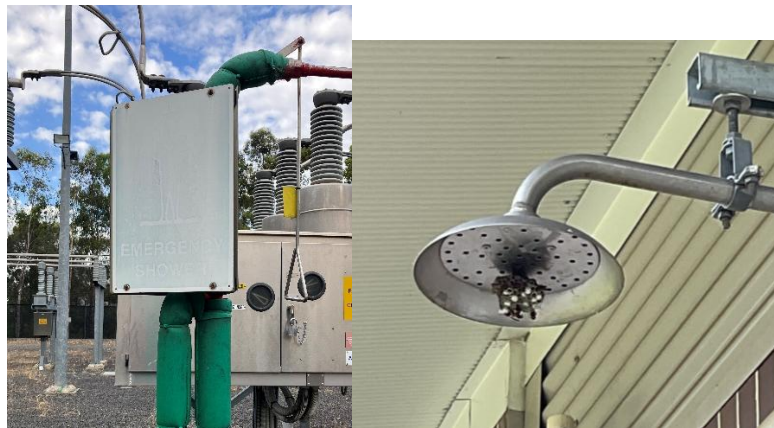
| Defect Description | Defect Photo | Task Details |
|---|---|---|
| <p><b>Deluge Showers</b><br/>– Damaged / Poor Condition</p> | | <p><b><u>Bushfire Defect</u></b></p> <ul style="list-style-type: none"><li>- No</li></ul> |
| <p><b><u>Indicators</u></b></p> <ul style="list-style-type: none"><li>- Deluge Shower is inoperable</li><li>- Leaking is present</li><li>- Valves / Taps are damaged</li></ul> <p>Major defects: When the deluge shower is unable to be operated as required</p> | | <p><b><u>Object Part</u></b></p> <ul style="list-style-type: none"><li>- 1002: Tank</li><li>- 1080: Valve</li><li>- 1490: Shower Head</li><li>- 1085: Piping</li></ul> |
| <p><b><u>Scope of Rectification Works</u></b></p> <p>Repair / Replace the defective equipment as required and ensure correct operation prior to leaving site.</p> | | |

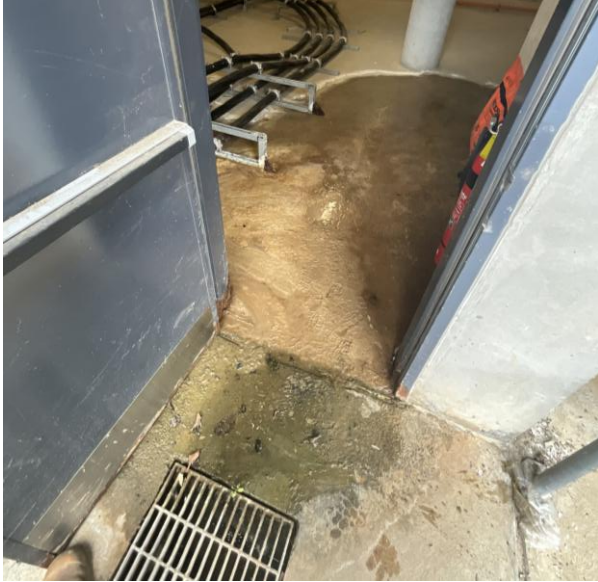
| Defect Description | Defect Photo | Task Details |
|---|---|---|
| <b>Stormwater System<br/>– Damaged / Poor Condition</b> | | <b><u>Bushfire Defect</u></b><br>- No |
| <b><u>Indicators</u></b><br><ul style="list-style-type: none"> <li>- Damaged or blocked stormwater pits</li> <li>- Stormwater not adequately draining away</li> <li>- Basements / Pits have excessive water pooling</li> </ul> | | <b><u>Object Part</u></b><br>- N/A: Stormwater System |
| <b><u>Scope of Rectification Works</u></b><br>Submit notification and raise DRA. For major or critical damage, call and advise design group for immediate assessment. | | <b><u>Cause Code</u></b><br><ul style="list-style-type: none"> <li>- 1059: Mechanical Failure</li> <li>- 1117: Foreign Object/Vermin</li> <li>- 1459: Rain</li> <li>- 1164: Unknown</li> </ul> |
