# Substation Defect Handbook

Document No. SMI 0002

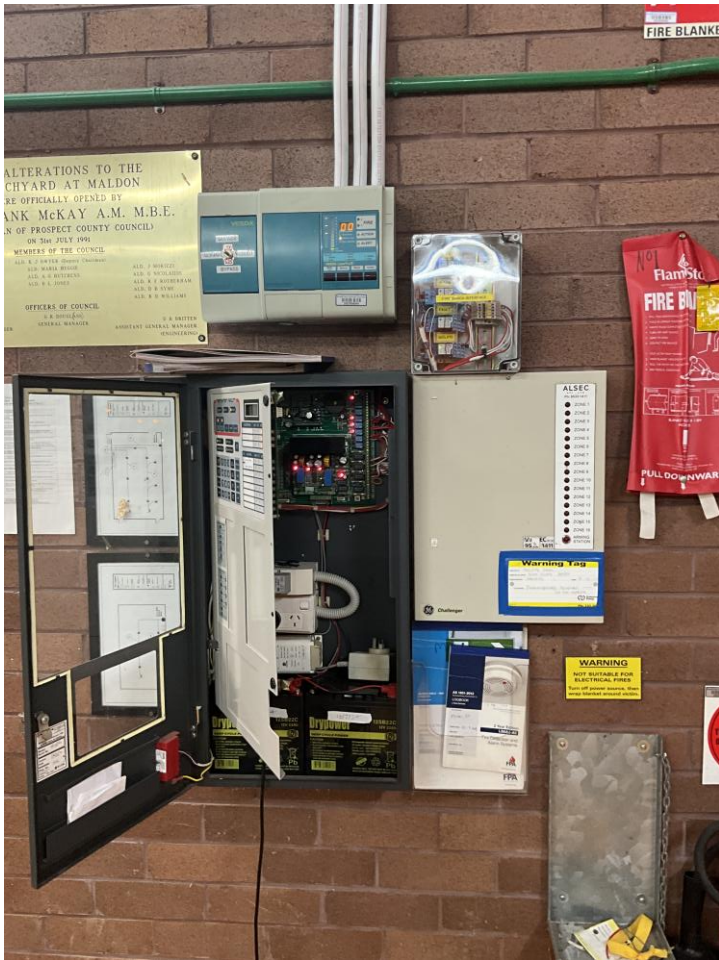
| Defect Description | Defect Photo | Task Details |
|---|---|---|
| <p><b>Fire System Assets</b><br/>– Faulty / Poor Condition</p> | | <p><b><u>Bushfire Defect</u></b></p> <p>- No</p> |
| <p><b><u>Indicators</u></b></p> <p>- Alarms are present</p> <p>- Fire Detection System not operating as expected</p> <p>- Equipment out of inspection date</p> <p>- Fire Assets are missing</p> <p>- Fire Assets have signs of tampering</p> <p>Major defects: When the fire system assets are not working as required</p> | | <p><b><u>Object Part</u></b></p> <p>- 1498: Fire extinguisher</p> <p>- 1496: Fire Blanket</p> <p>- 1493: Fire Alarm Detector</p> <p>- 1494: Control Panel</p> |
| <p><b><u>Scope of Rectification Works</u></b></p> <p>Repair / Replace damaged equipment as required. Ensure that all Fire System assets are working as intended prior to leaving site.</p> | | |

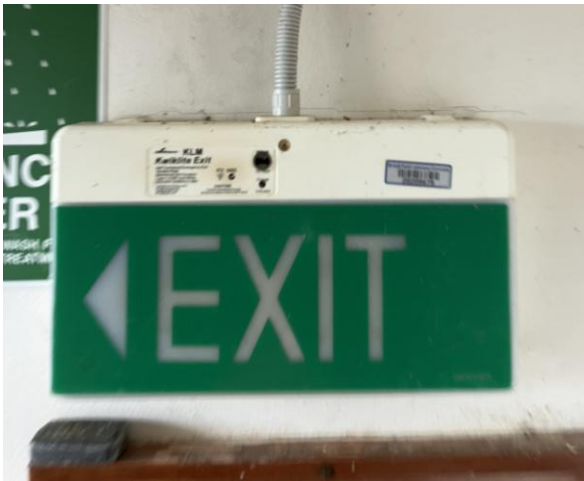
| Defect Description | Defect Photo | Task Details |
|---|---|---|
| <b>Emergency Lighting<br/>– Fault / Poor Condition</b> | | <b><u>Bushfire Defect</u></b><br><br>- No |
| <b><u>Indicators</u></b><br><br>- Emergency lighting is inoperable<br><br>- Fails 90-minute testing<br><br>- Exit Lighting is illegible<br><br>- Lighting is cracked / damaged<br><br>Major defects: When Emergency Lighting is inoperable across the whole room/site | | <b><u>Object Part</u></b><br><br>- 1405: Cable<br>- N/A: Light<br>- N/A: LV Fuses/CB/RCD |
| <b><u>Scope of Rectification Works</u></b><br><br>Repair / Replace emergency lighting as required and conduct a 90-minute test to ensure correct operation. | | |

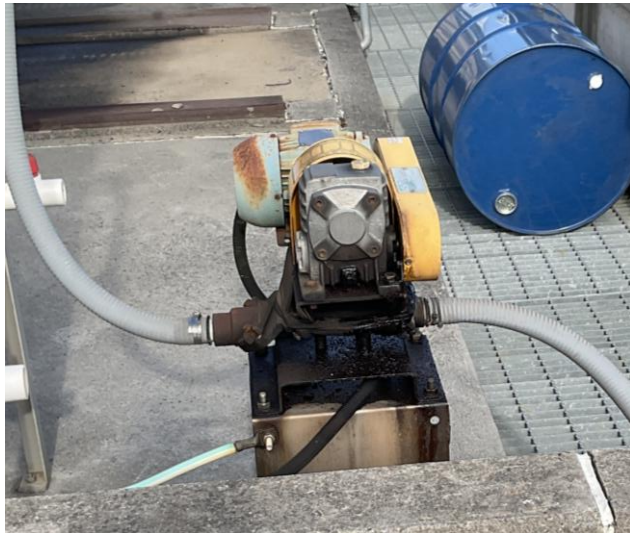
| Defect Description | Defect Photo | Task Details |
|---|---|---|
| <b>Oil Water Separator<br/>– Motor / Pump Faulty</b> | | <b><u>Bushfire Defect</u></b><br><br>- No |
| <b><u>Indicators</u></b><br><br>- OWS is pumping but bund water is not draining<br><br>- OWS is not running when bund is full<br><br>- Motor is very loud when running<br><br>Major defects: When the OWS motor or pump is inoperable and require replacement | | <b><u>Object Part</u></b><br><br>- 1081: Pump<br>- 1423: Motor |

| Defect Description | | Defect Photo | Task Details | |
|---|--|---|---|---|
| Repair / Replace equipment as required and ensure bund is drained of any water prior to leaving site. | | | | |

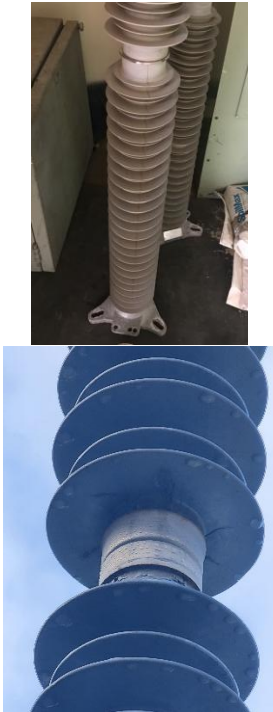
| Defect Description | Defect Photo | Task Details |
|---|---|---|
| <b>Surge Divertors</b><br>– Damaged / Poor Condition | | <b><u>Bushfire Defect</u></b><br><br>- No |
| <b><u>Indicators</u></b><br><br>- Visible cracks or damage<br><br>- Surge Diverter has operated during fault operations<br><br>- Signs of thermal heating around the base/earth connection of surge diverter<br><br>Major defects: When the damage poses a hazard to the safety of staff or the network | | <b><u>Object Part</u></b><br><br>- 1265: Insulator<br>- 1031: Base |
| <b><u>Scope of Rectification Works</u></b><br><br>Replace any surge divertors that are damaged or that have operated during fault operations. | | |

| Miscellaneous Defect Index | |
|---|---|
| Surge Divertors – Damaged / Poor Condition | <a href="#"><u>102</u></a> |

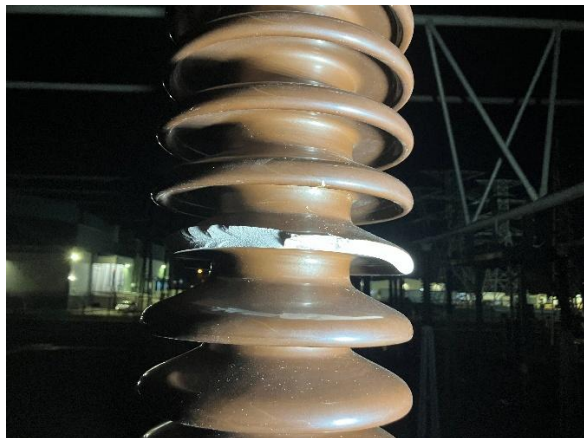
| Defect Description | Defect Photo | Task Details |
|---|---|---|
| <b>Bushings / Insulators<br/>– Major Damage</b> | | <b><u>Bushfire Defect</u></b><br><br>- No |
| <b><u>Indicators</u></b><br><br>- Major cracking present<br><br>- Large chunks of insulator missing<br><br>- Major treeing/tracking | | <b><u>Object Part</u></b><br><br>- 1003: Bushing<br>- 1265: Insulator |
| <b><u>Scope of Rectification Works</u></b><br><br>Inspect surrounding bushings for signs of similar damage and replace all defective bushings as required. | | |

| Miscellaneous Defect Index | |
|---|---|
| Bushings / Insulators – Major Damage | <a href="#"><u>104</u></a> |
